**2011 NDIA GROUND VEHICLE SYSTEMS ENGINEERING AND TECHNOLOGY
SYMPOSIUM**
POWER AND MOBILITY (P&M) MINI-SYMPOSIUM
AUGUST 9-11 DEARBORN, MICHIGAN

**MILITARY FUEL AND ALTERNATIVE FUEL EFFECTS ON A MODERN
DIESEL ENGINE EMPLOYING A FUEL-LUBRICATED HIGH PRESSURE
COMMON RAIL FUEL INJECTION SYSTEM**

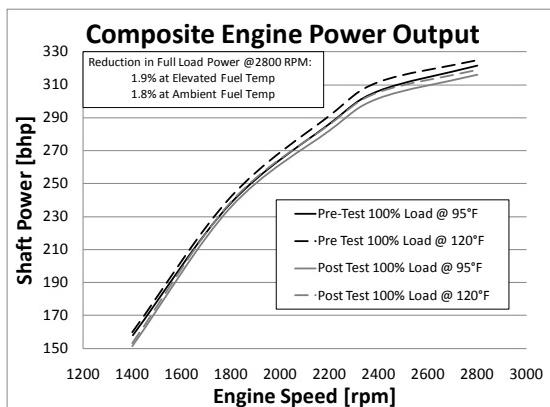
Figure 3 – ULSD Powercurves

As previously stated, engine powercurves were completed at the start and end of testing to determine overall engine performance variation over the test duration. Figures 3, 4, 5, and 6 show the pre-and post-test full load powercurve for ULSD, JP-8, 50/50 JP-8/SPK, and SPK test fuels respectively. Full load power degradation remained similar throughout testing. It is worth mentioning that during testing, problems with the engine's turbocharger assembly were experienced, resulting in continuous engine boost degradation throughout the first three tests.

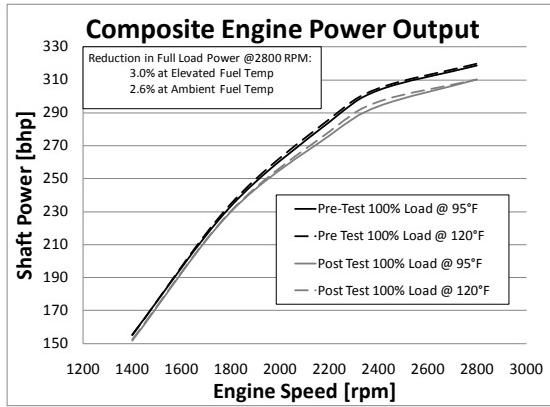
Figure 4 – JP-8 Powercurves

The problem was later identified to be an issue with vane movement on the variable geometry turbo (VGT), and was not attributed to testing conditions. At the completion of the third test (50/50 JP-8/SPK), the engine's turbocharger assembly was replaced in an effort to avoid any PCM commanded de-rating due to its inability to meet desired boost targets.

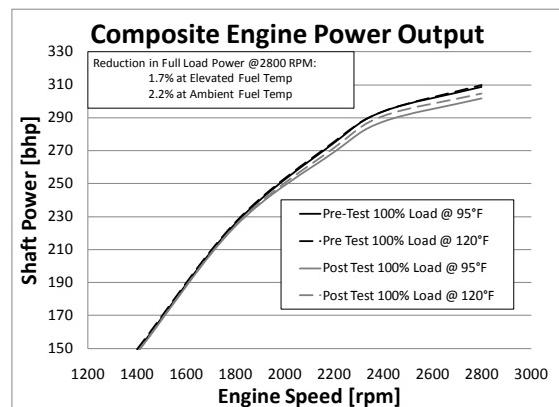
Figure 5 – 50/50 JP-8/SPK Powercurves

As expected, this phenomenon was the primary cause of engine power variation across testing, and masked any real quantification of engine power degradation due to fuel system impacts. Despite this phenomenon, engine fueling was consistently maintained throughout testing, thus avoiding the invalidation of the overall test goals to determine the fuels interaction with the fuel system. Over the test duration, engine fuel consumption rates, generated rail pressure, and fuel system control commands remained consistent providing a good comparison for fuel system compatibility between each fuel tested. Despite the boost pressure degradation experienced, no major differences in engine output were noted between fuels, or across the test duration for each tested fuel.

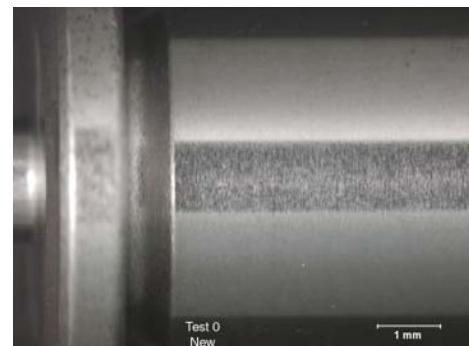
Figure 12 – Upper Piston, Injector Hydraulic Coupler, New

Consistent with the high pressure fuel pump inspection, fuel injectors from each test were removed and disassembled for inspection and photographs. Inspections were made to the hydraulic coupler pistons, control valve, control plates, injector needle, and nozzle. With the exception of slight deposition differences between the diesel and military fuels (primarily noticed in coloring), no other differing patterns could be identified between the baseline diesel test and the JP8 and SPK tests. From the inspection, the only internal injector components showing any appreciable wear patterns were the upper piston of the hydraulic coupling. From the inspection, it appeared that the piezo stack imparted a slight side load on the upper piston causing a reacting wear scar to be formed on the surface. This wear scar was seen in each of the test fuels, and was found to be overall similar in size and condition between baseline and military fuels. Figure 12, 13, 14, 15, and 16 shows the magnified photo of the upper hydraulic coupler piston for the new, ULSD, JP-8, 50/50 JP-8/SPK, and SPK test respectively.

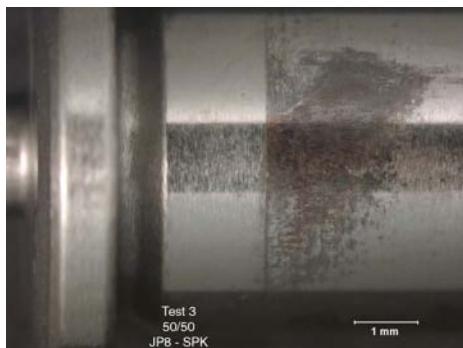
Figure 15 – Upper Piston, Injector Hydraulic Coupler, 50/50 JP-8/SPK

Although this wear did not impact the testing at hand, this type of wear is typical of types of wear that can be detrimental to fuel injector function if continued. Binding or sticking of the hydraulic coupler will impair the action of the control valve which can potentially result in no fuel being injected into the engine, or a constant flow of injected fuel, both requiring immediate fuel injector replacement to ensure proper engine operation.
